Job #26707746

Masonry Fireplace Inspection

18 Southern Avenue, Rensselaer, NY 12144 USA

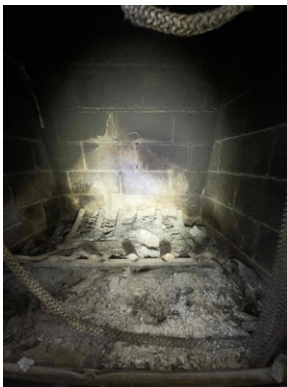
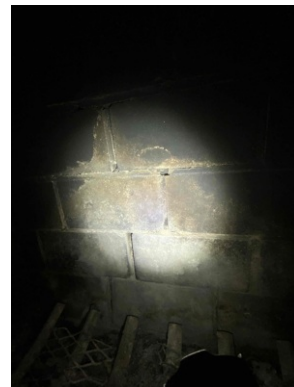
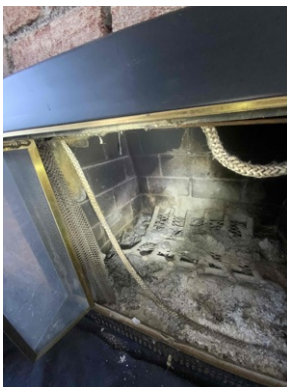
Is the interior of the fireplace in sound condition?

- ✓ Deteriorated mortar - The firebox has deteriorated mortar joints. Firebrick are to be laid with a refractory mortar.
- ✓ Gaps / cracks in mortar - There are gaps in the mortar joints. The smallest gap in the masonry can create a pathway for rogue flue gases to be drawn into areas of the structure that could pose a potential fire or carbon monoxide threat. Fireboxes are to be laid with refractory mortar that can withstand heat and moisture.

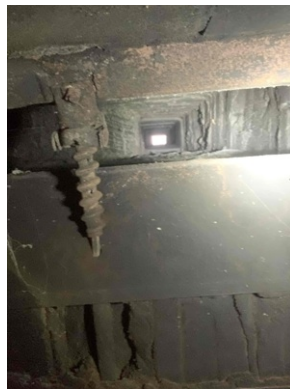
- ✓ The smoke chamber is unparged which does not meet current code. An unparged smoke chamber can increase the residency time of smoke and flue gasses which can lead to smoke smells, an increase in potentially flammable creosote build up and allow dangerous flue gasses to escape the structure. NFPA 211 11.2.1.13 The inner surfaces of the smoke chamber shall be parge coated smooth, with an insulating refractory mortar, and not inclined more than 45 degrees from vertical.
- ✓ The smoke chamber is not properly sized. The smoke chamber should not be taller than the width of the masonry firebox. NFPA 211 standards 11.2.1.11 The smoke chamber height shall not be greater than the inside width of the fireplace room opening. 11.2.1.12 The smoke chamber depth shall not be greater than the depth of the fireplace fire chamber. The smoke chamber will need to be hand parged to correct parameters.

Found smoke chamber to be oversized and unparged
Cracks and gaps in flue tile

- (1) parge smoke chamber for smooth transition for flue gasses
- (2) resizes smoke chamber for optimal draft
- (3) liner for fireplace or install a wood stove insert

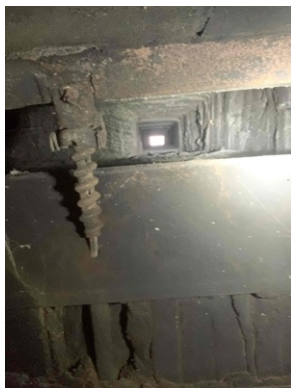
What is the condition of the smoke chamber?

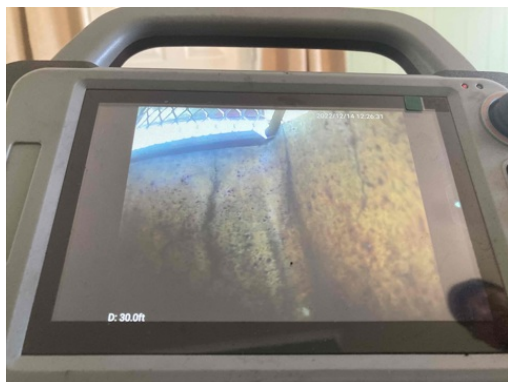
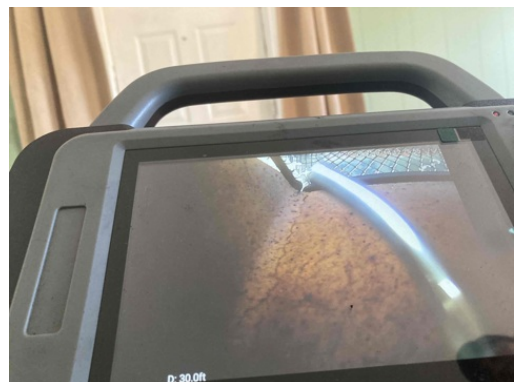
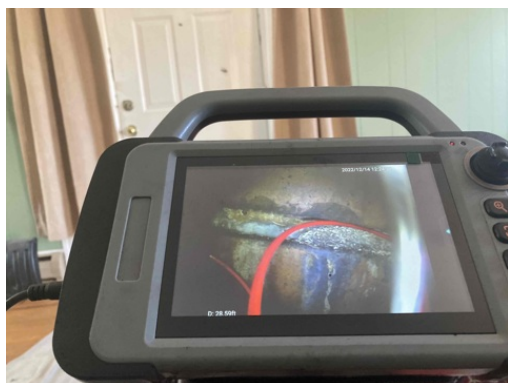
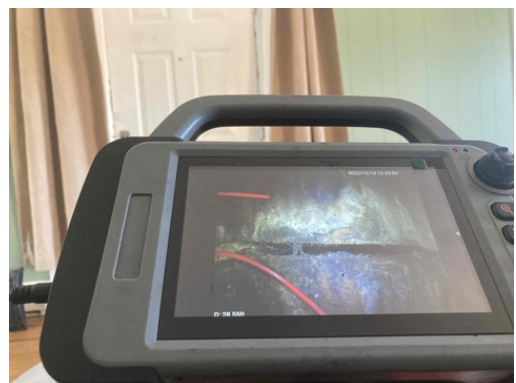
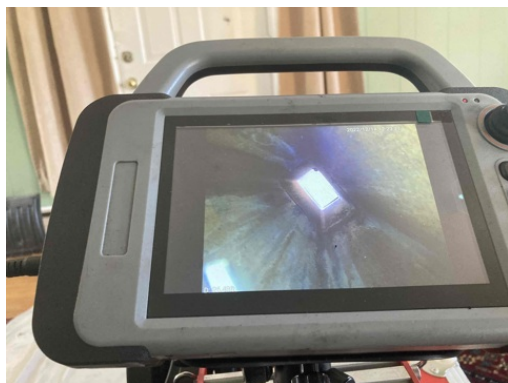
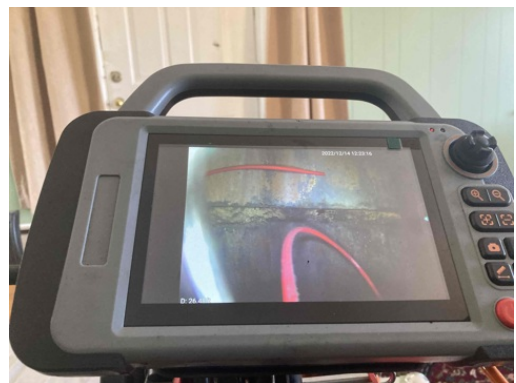
- ✓ Missing mortar - The mortar joints between the flue tiles are no longer intact. These missing or deteriorated mortar joints prevent the flue tiles from properly conveying the byproducts of

combustion to the exterior of the home. Flammable creosote can now store in uncontained areas of the flue that can no longer be swept which increases the potential of a high heat event such as a chimney fire. NFPA 211 14.9* Damaged or Deteriorated Liners. If the flue liner in a chimney has softened, cracked, or otherwise deteriorated so that it no longer has the continued ability to contain the products of combustion (i.e., heat, moisture, creosote, and gases), the liner shall be either removed and replaced, repaired, or relined with a listed liner system or other approved material that will resist corrosion, softening, or cracking from flue gases at temperatures appropriate to the class of chimney service.

✔ Vertical crack - There are tiles that have vertical cracks. Vertical cracks are an indication that there has been a sudden rapid heating of the tile. This rapid heating causes thermal shock to the tile. Thermal shock causes the inside of the tile to heat more rapidly than the exterior of the tile. When this occurs, the tile will crack vertically. This flue tile can no longer perform its intended function. The chimney must be relined. NFPA 211 14.9* Damaged or Deteriorated Liners. If the flue liner in a chimney has softened, cracked, or otherwise deteriorated so that it no longer has the continued ability to contain the products of combustion (i.e., heat, moisture, creosote, and gases), the liner shall be either removed and replaced, repaired, or relined with a listed liner system or other approved material that will resist corrosion, softening, or cracking from flue gases at temperatures appropriate to the class of chimney service.

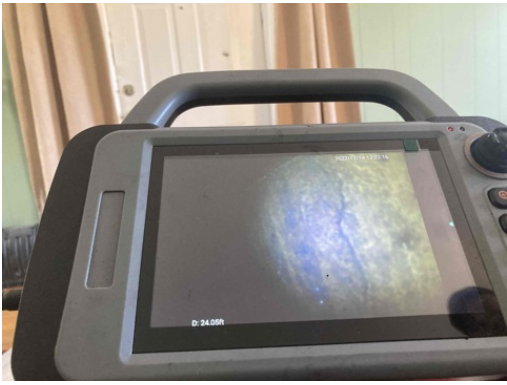
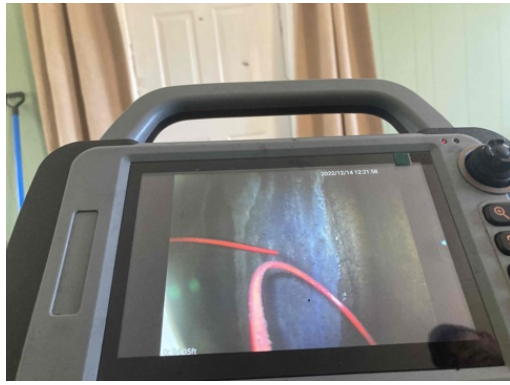
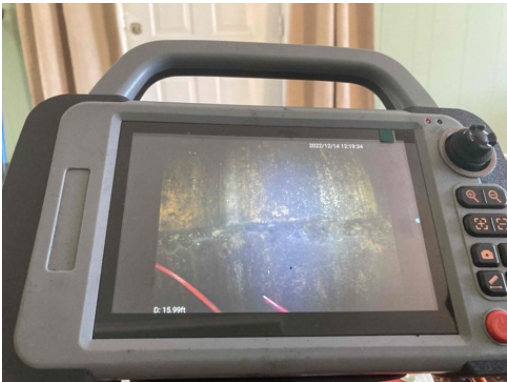
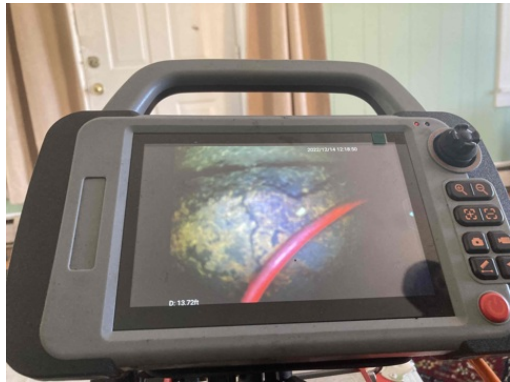
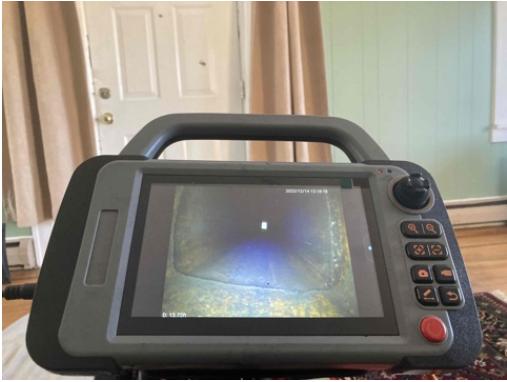
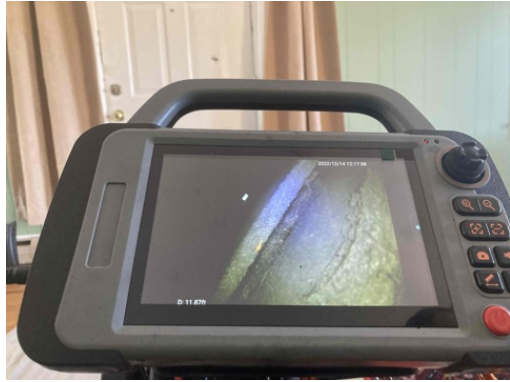
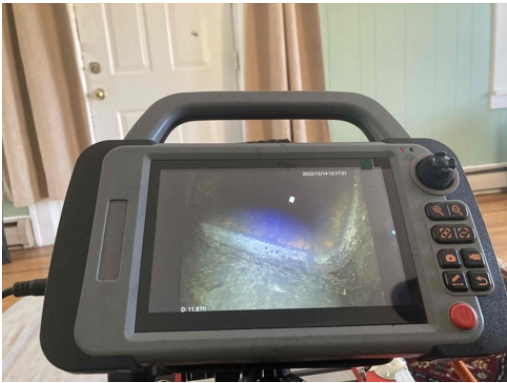
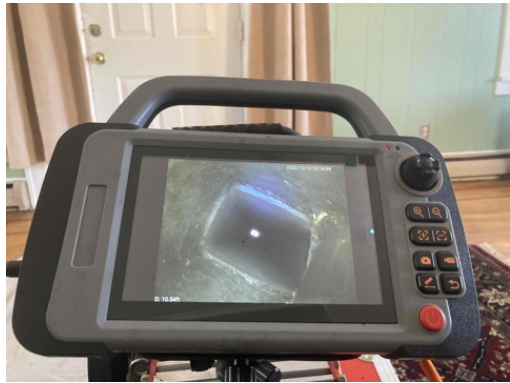
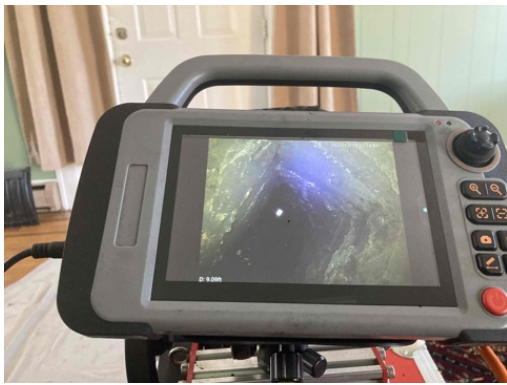
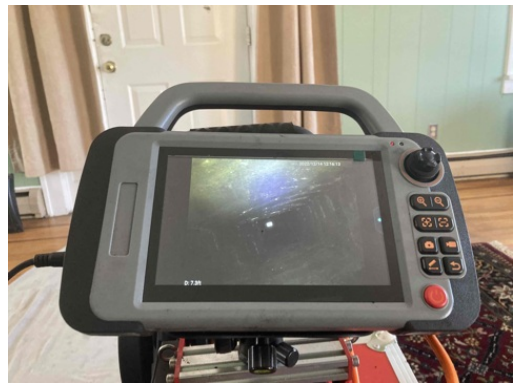
Are there cracks, gaps or other issues present with the flue tiles? If liner is present, are there any obvious signs of deterioration?
